# **Testing Requirements for Refractory Materials**

# Testing Requirements for Refractory Materials

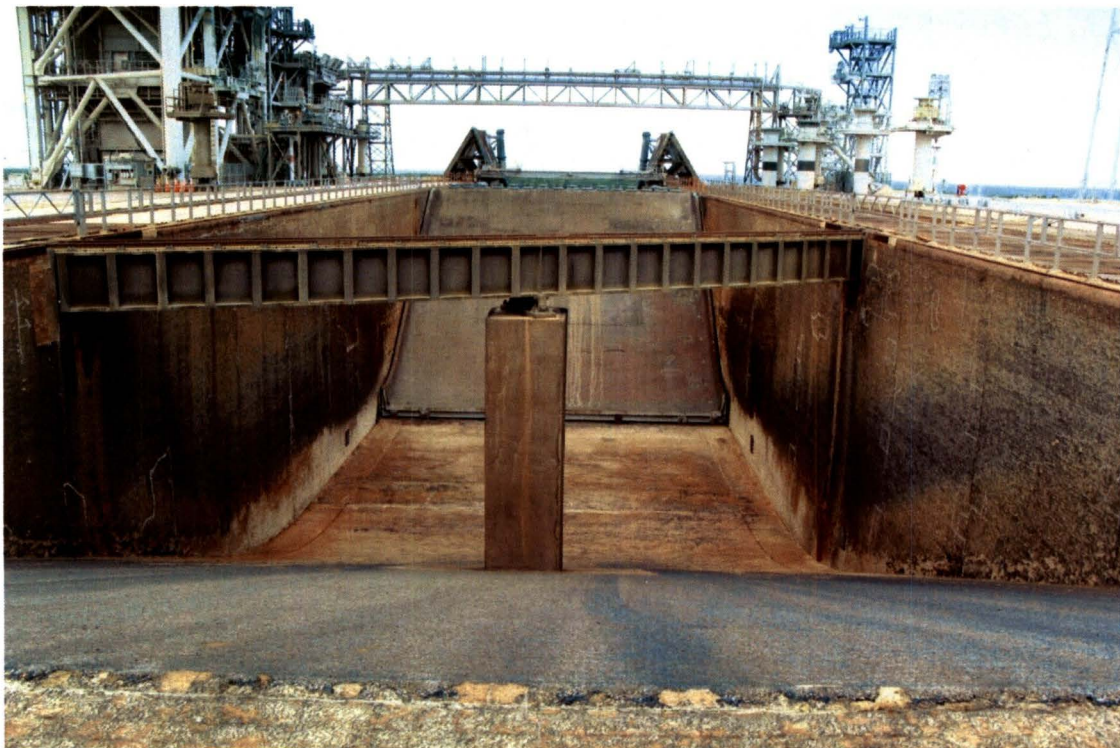
Figure 4 shows a view of the flame deflector underneath the SRBs. The image shows the structural steel at the bottom of the deflector, which is protected with Fondur Fyre. Figure 5 shows the SSME flame trench and deflector.

**Figure 5. SSME Flame Trench and Deflector**

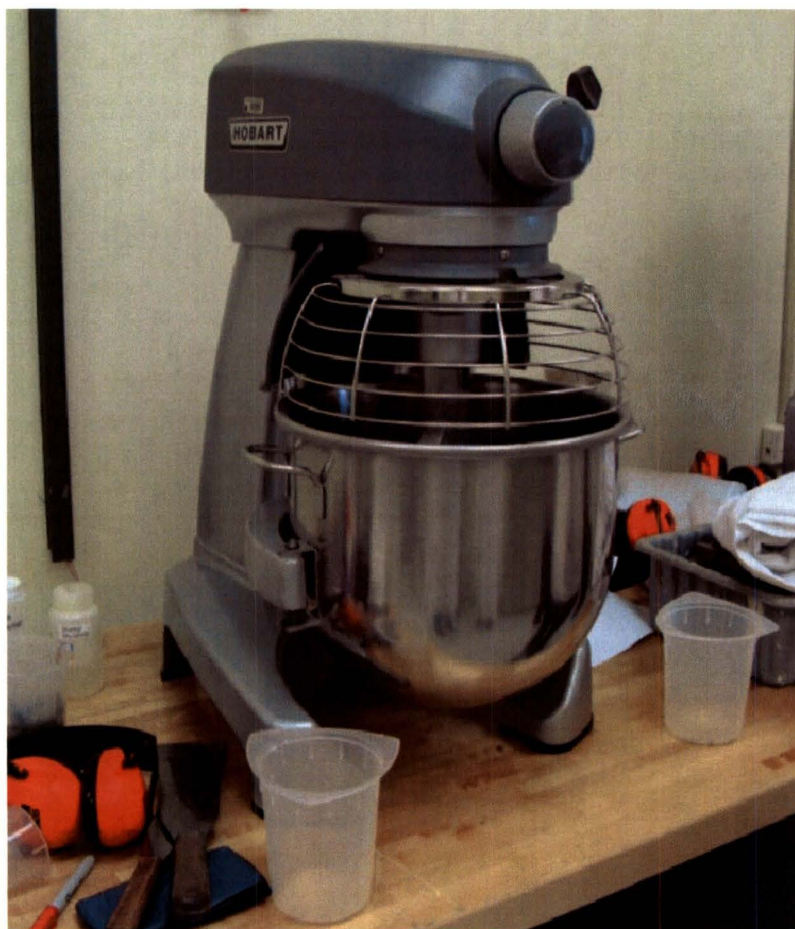
As quickly as possible following the mixing phase, the wet cementitious material should be packed into appropriate molds for the tests to be conducted. The product is then consolidated using a vibration table until the top surfaces appear smooth. The filled molds are then placed in a humidity chamber (greater than 95% humidity) at ambient temperature for a curing period of 24 hours. The specimens are then removed from the molds and are allowed to continue curing under ambient conditions for at least 7 days.

**Figure 14. Paddle Mixer Used at KSC To Prepare Refractory Samples**

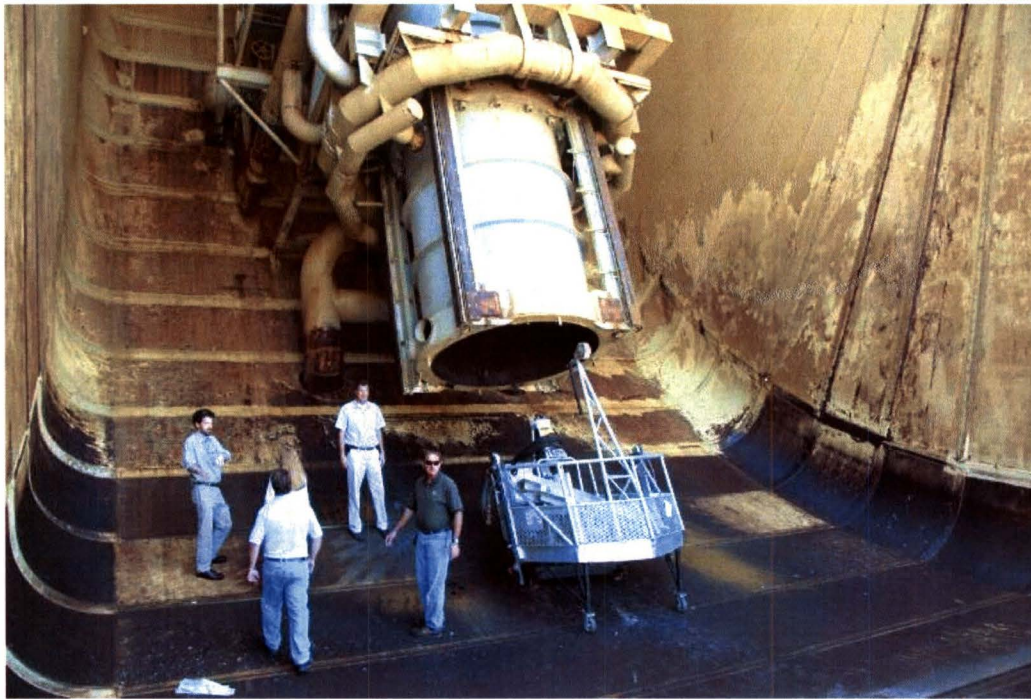
Figure 37 shows the relative size of the flame deflector in relation to members of the refractory site review team.

**Figure 37. View of the A-2 Flame Duct and Diffuser**

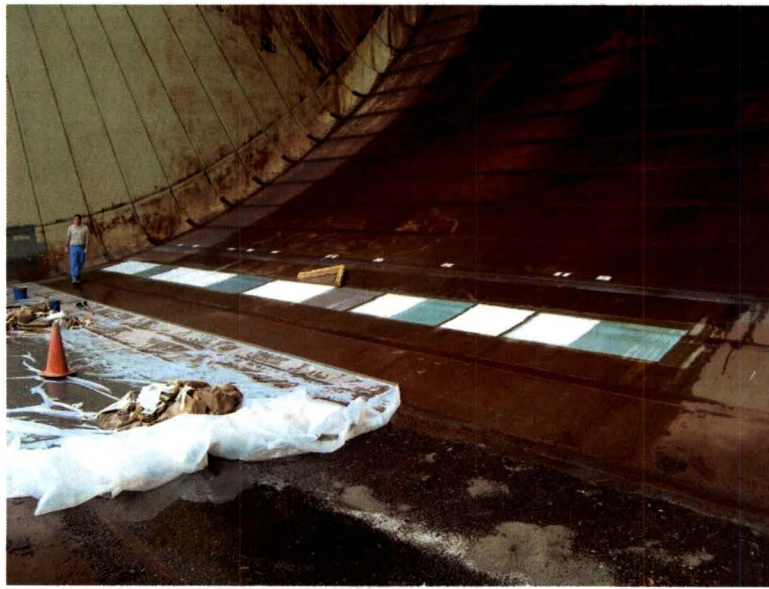
As a part of a prior project, NASA Corrosion Test Laboratory personnel photo-documented the B-2 Test Stand flame deflector (Figure 39).

Similar to the A-2 Test Stand discussed in 6.1.1, the B-2 test stand is a steel structure that is much larger in scale. Figure 39 is used to give a comparative size of the B-2 flame duct in relation to others that are discussed in this report.

**Figure 39. Stennis B-2 Flame Deflector**

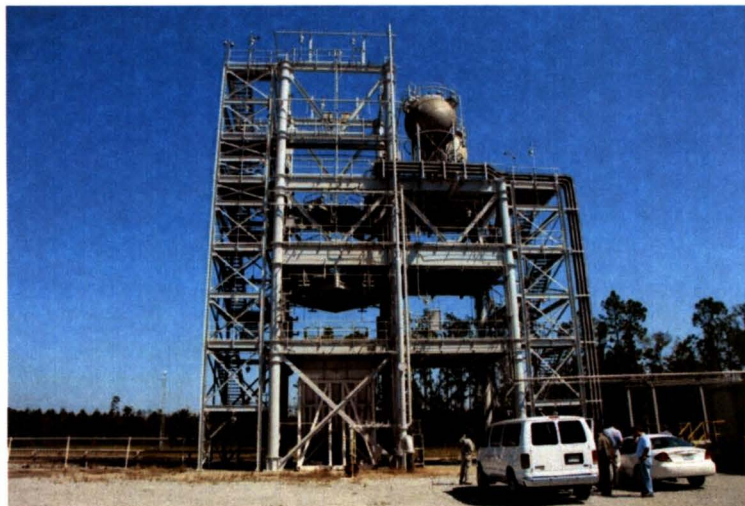
The E-2 facility is a multicell complex that is capable of testing intermediate-size engines in both the vertical and horizontal configurations (Figure 41).

**Figure 41. E-2 Cell 1 Test Stand at Stennis Space Center**

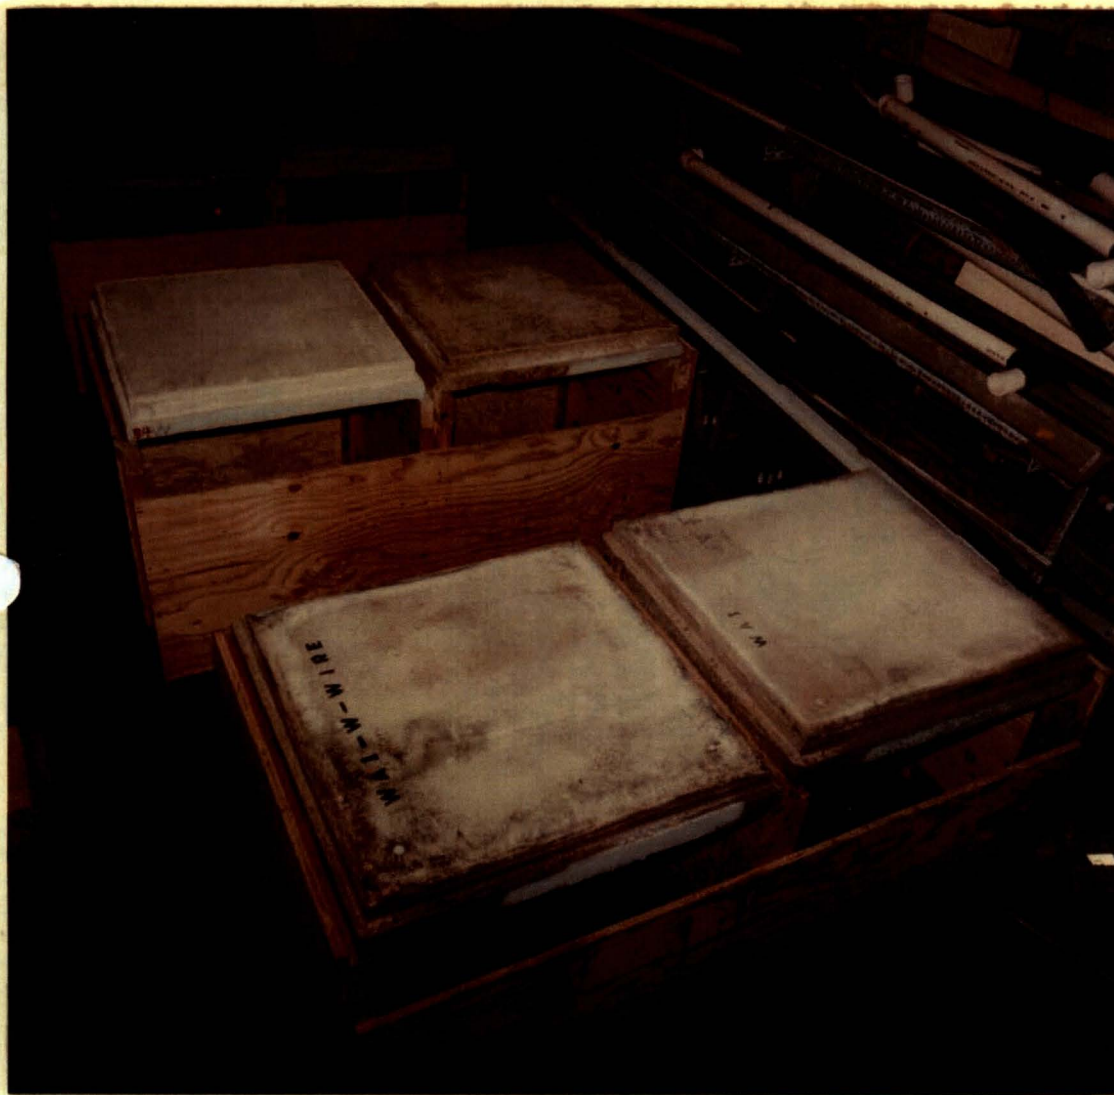
FIGURE 2.  
TEST PANELS ON INSPECTION RACKS.

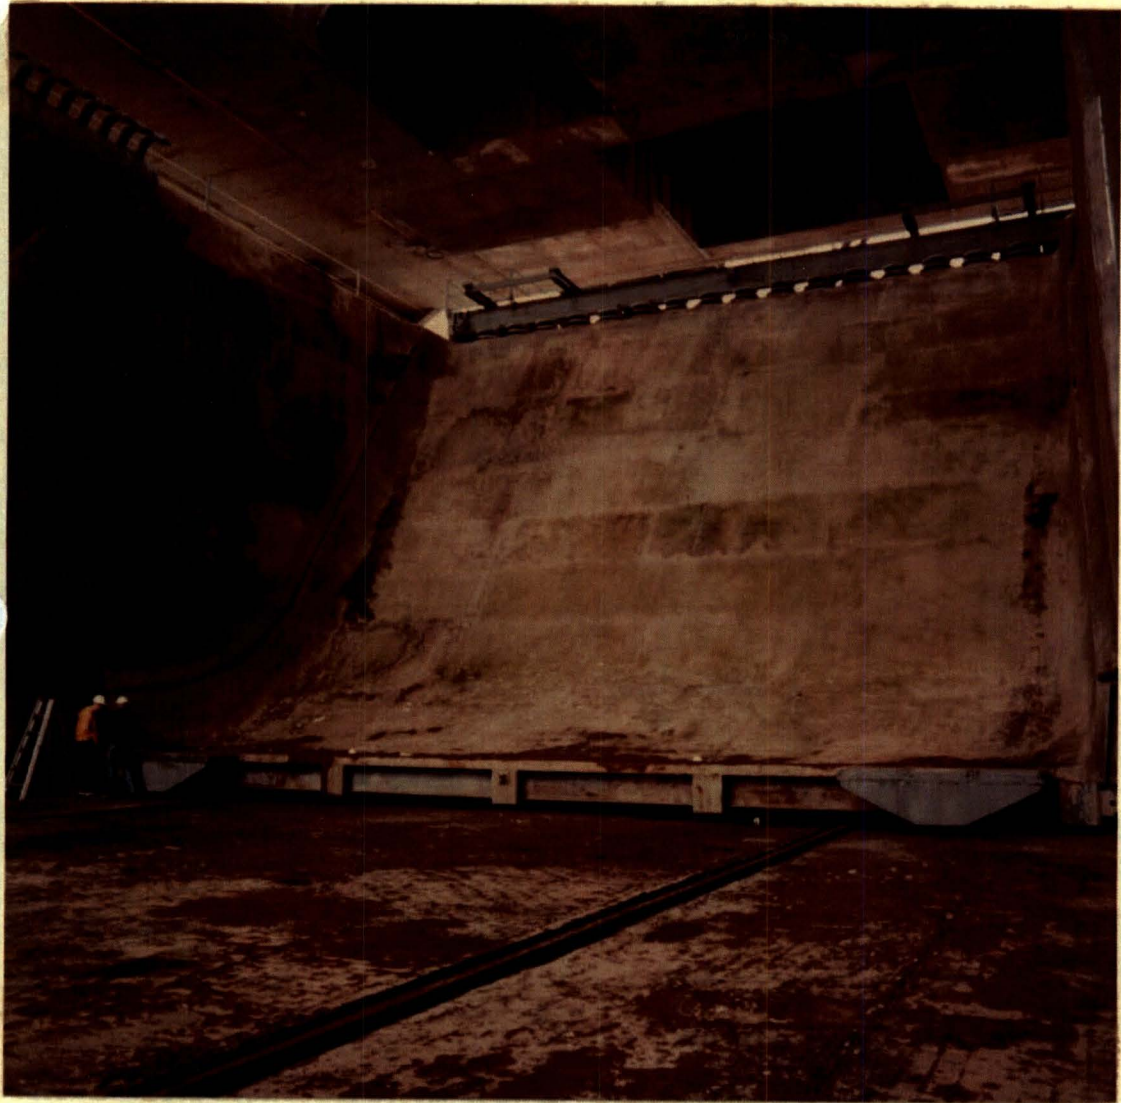
FIGURE 3.  
SRB FLAME DEFLECTOR AND TEST FRAMES.

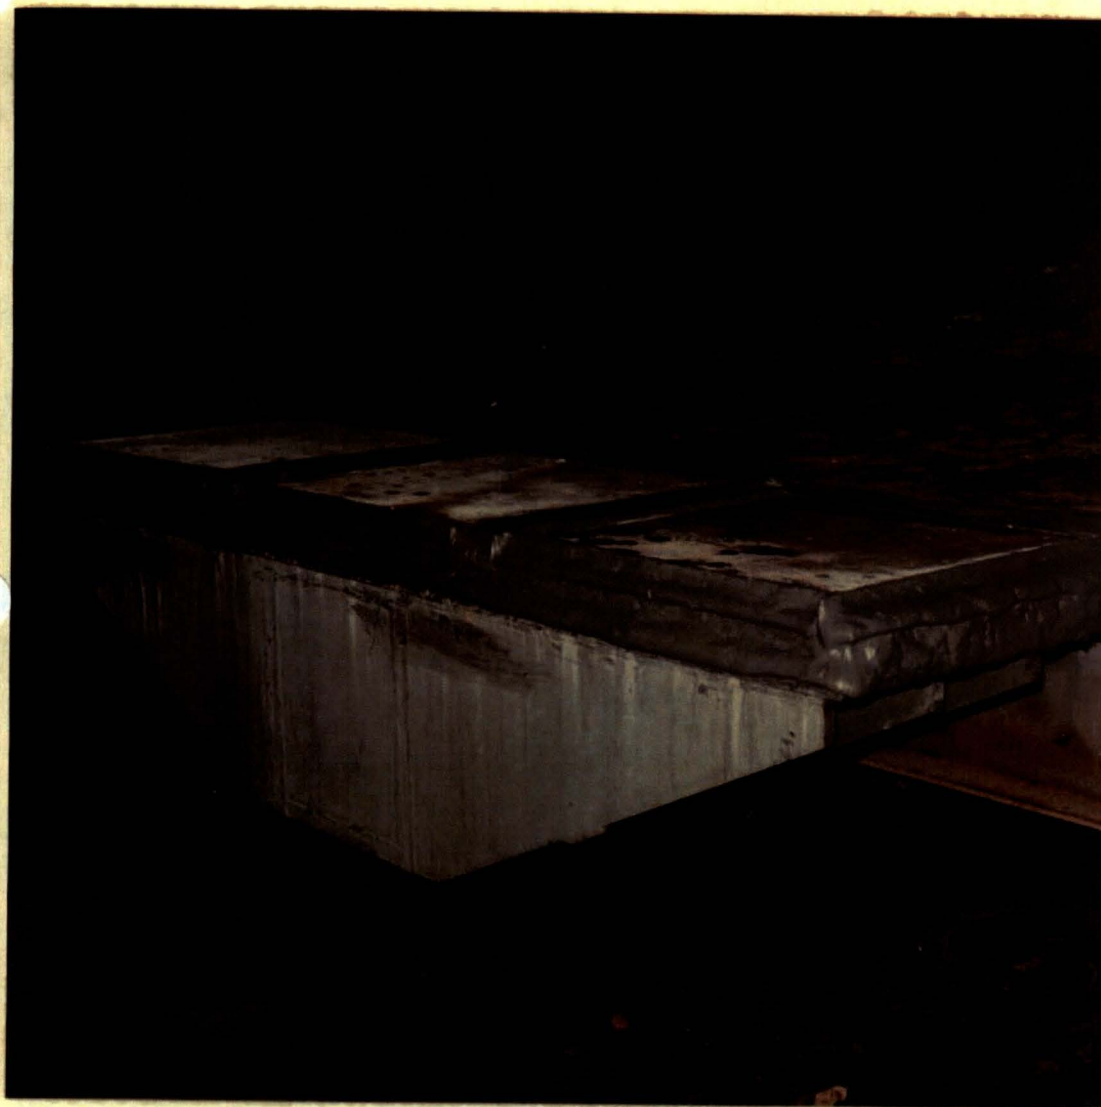
FIGURE 4.  
EAST TEST FRAME WITH TEST PANELS INSTALLED.

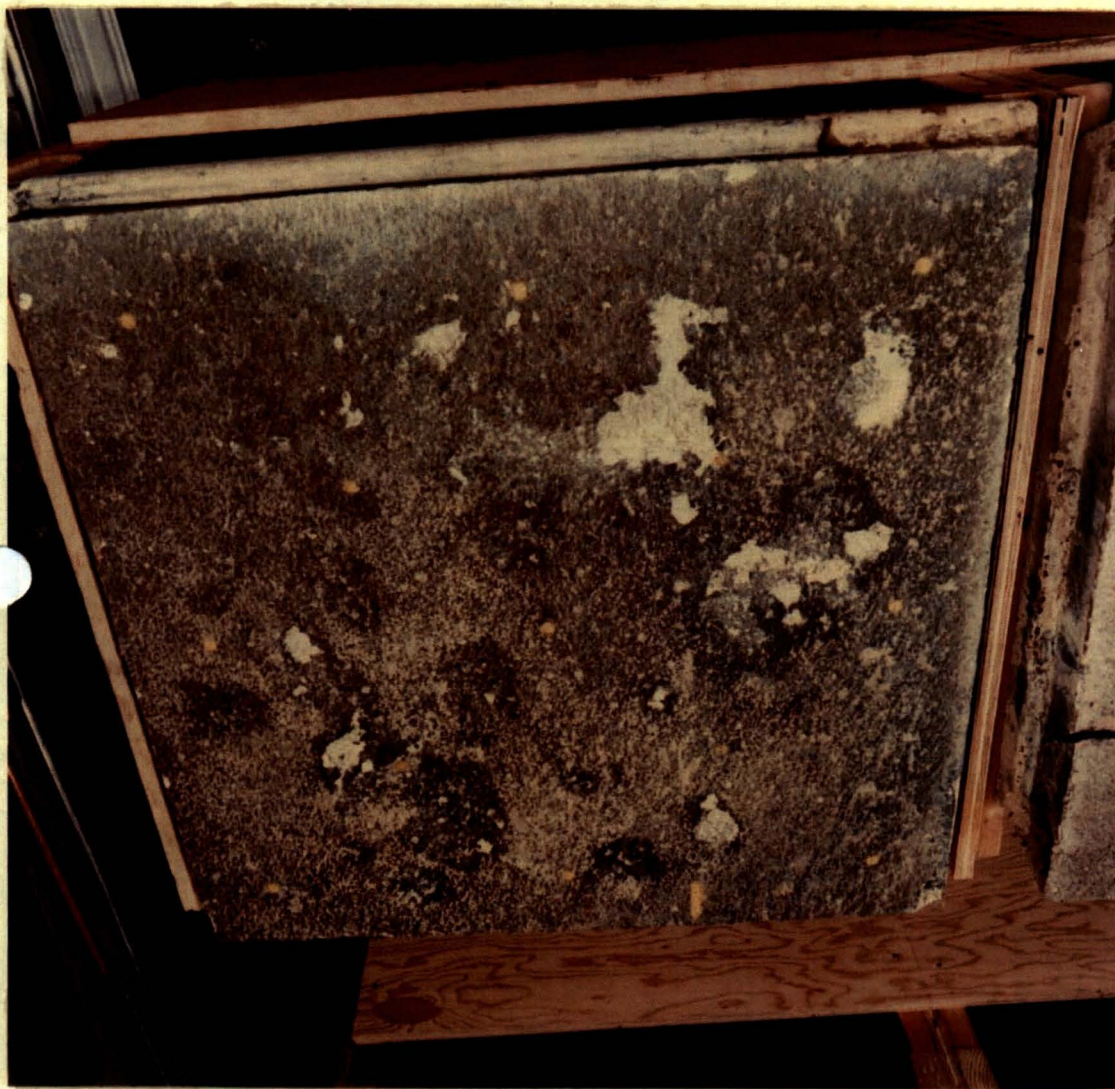
FIGURE 8.  
PANEL 1, ON INSPECTION RACK, AFTER LAUNCH.

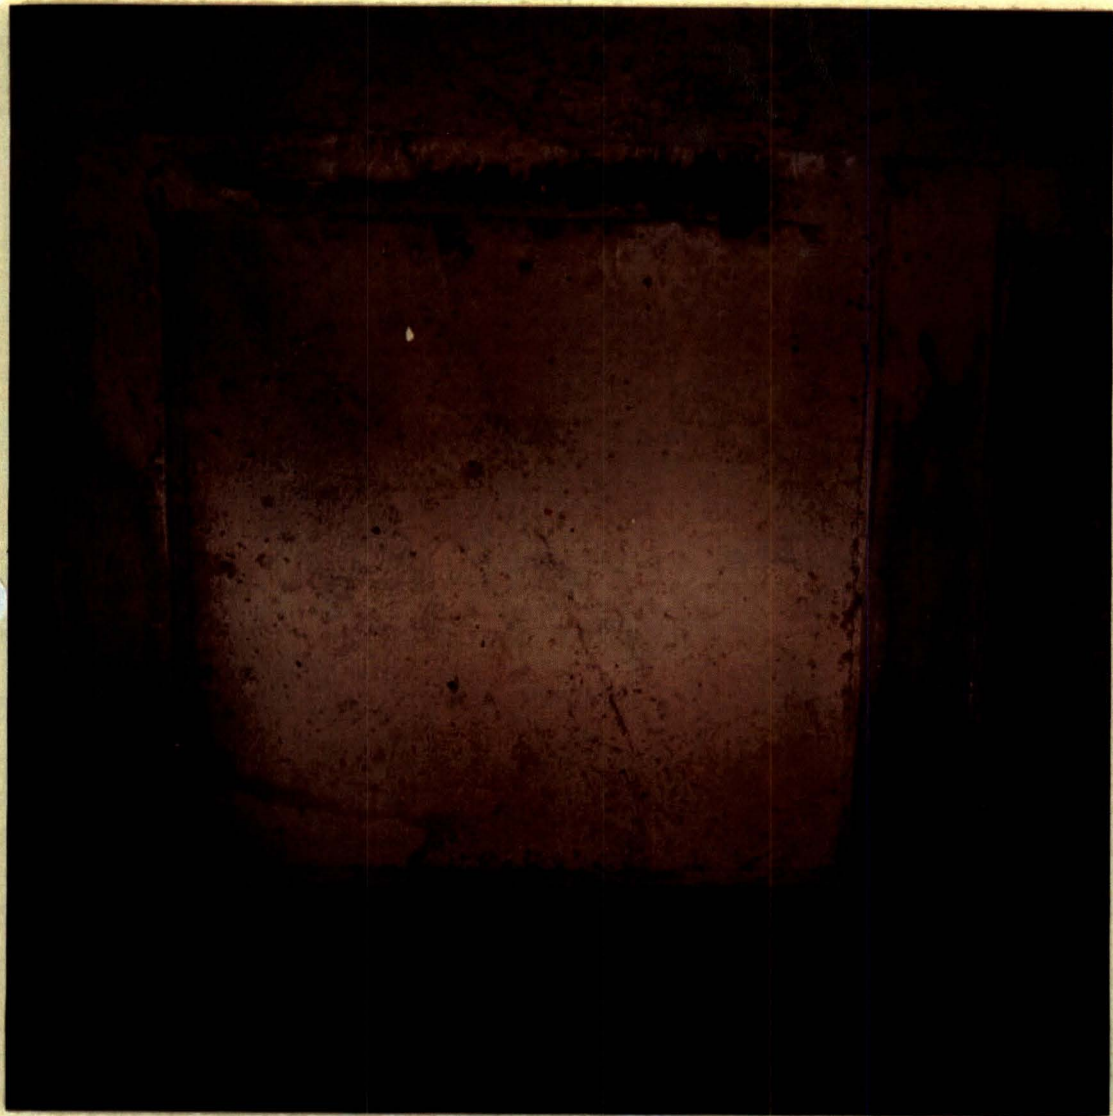
FIGURE 11.  
PANEL 2, IN TEST FRAME, AFTER LAUNCH.

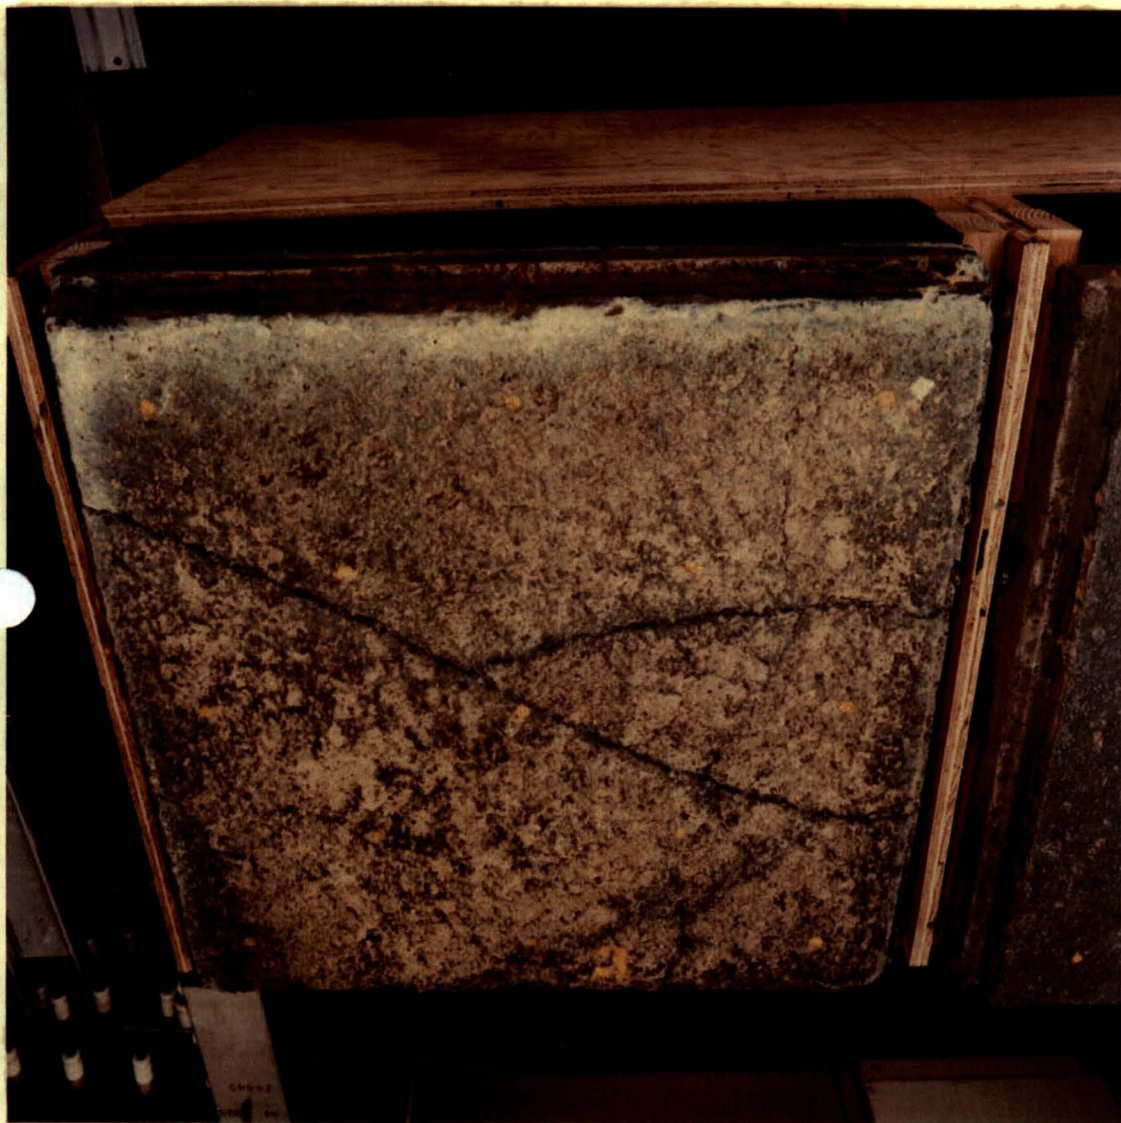
FIGURE 16.  
PANEL 3, IN INSPECTION RACK, AFTER LAUNCH.

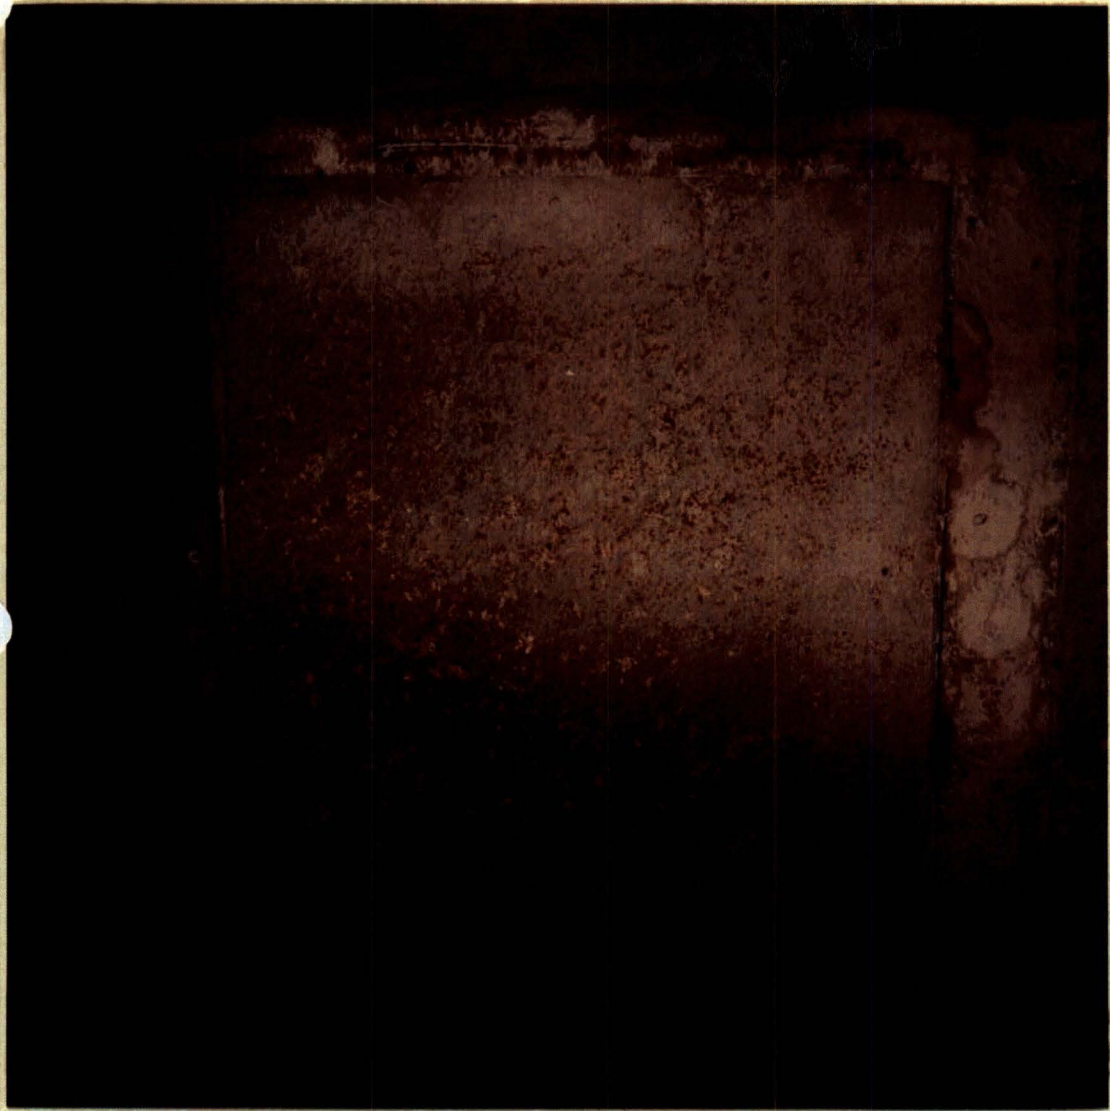
FIGURE 19.  
PANEL 4, IN TEST FRAME, AFTER LAUNCH.

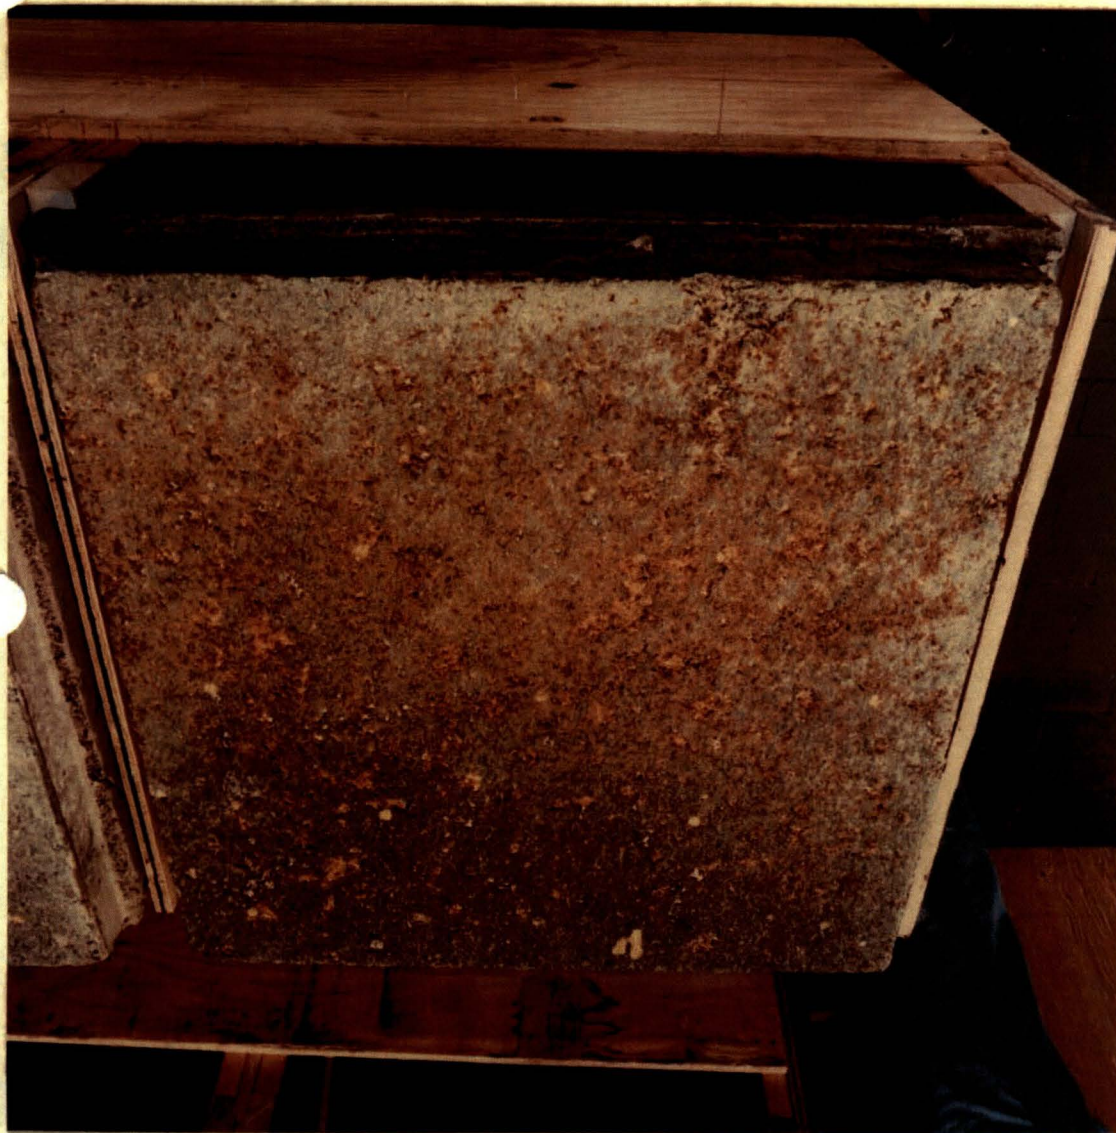
FIGURE 20.  
PANEL 4, ON INSPECTION RACK, AFTER LAUNCH.

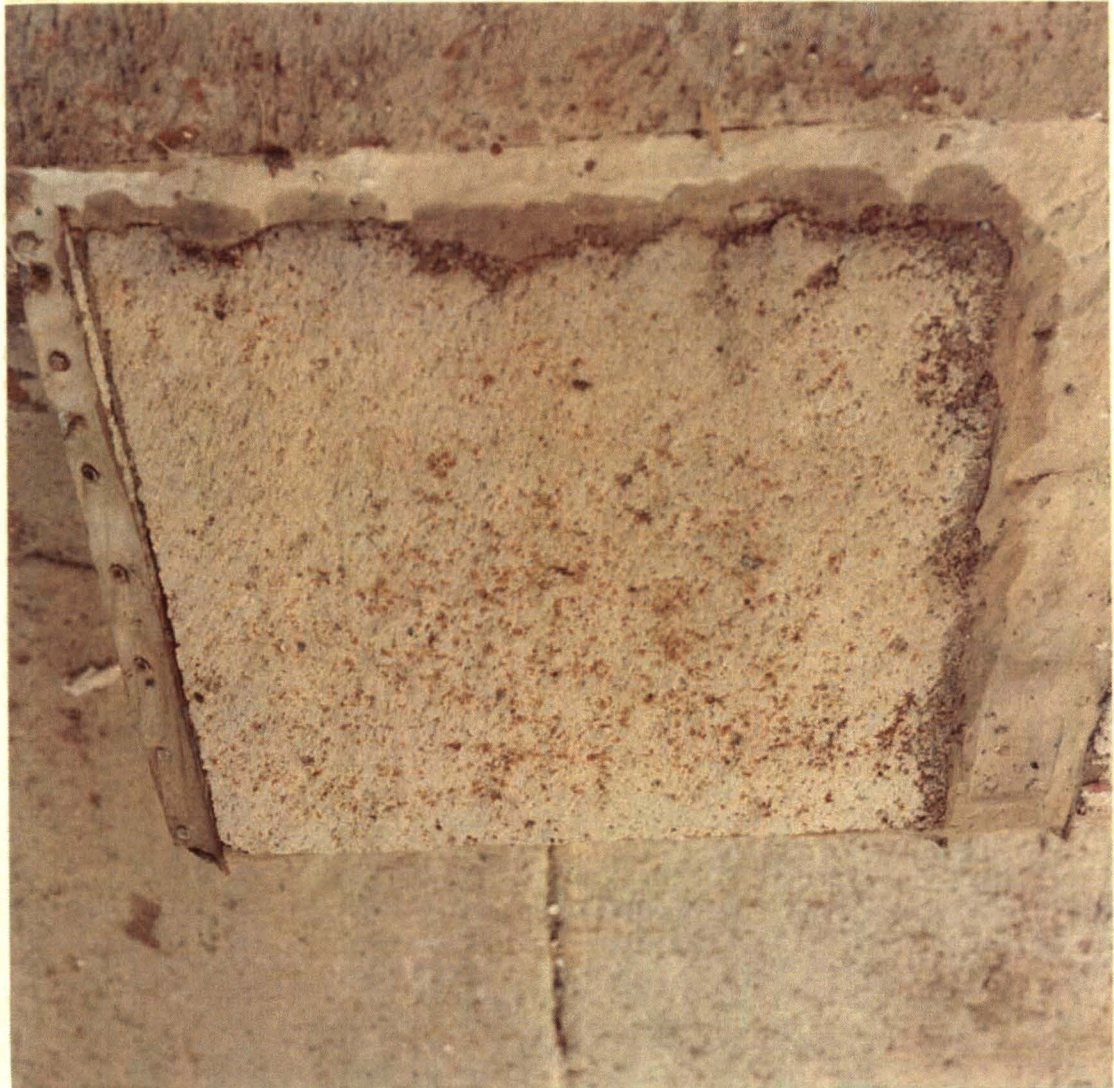
FIGURE 5

PANEL 4 IN TEST FRAME, POSITION 1, AFTER STS-2 LAUNCH  
WAHL WRP-3 WITH CARBON STEEL WIRE.

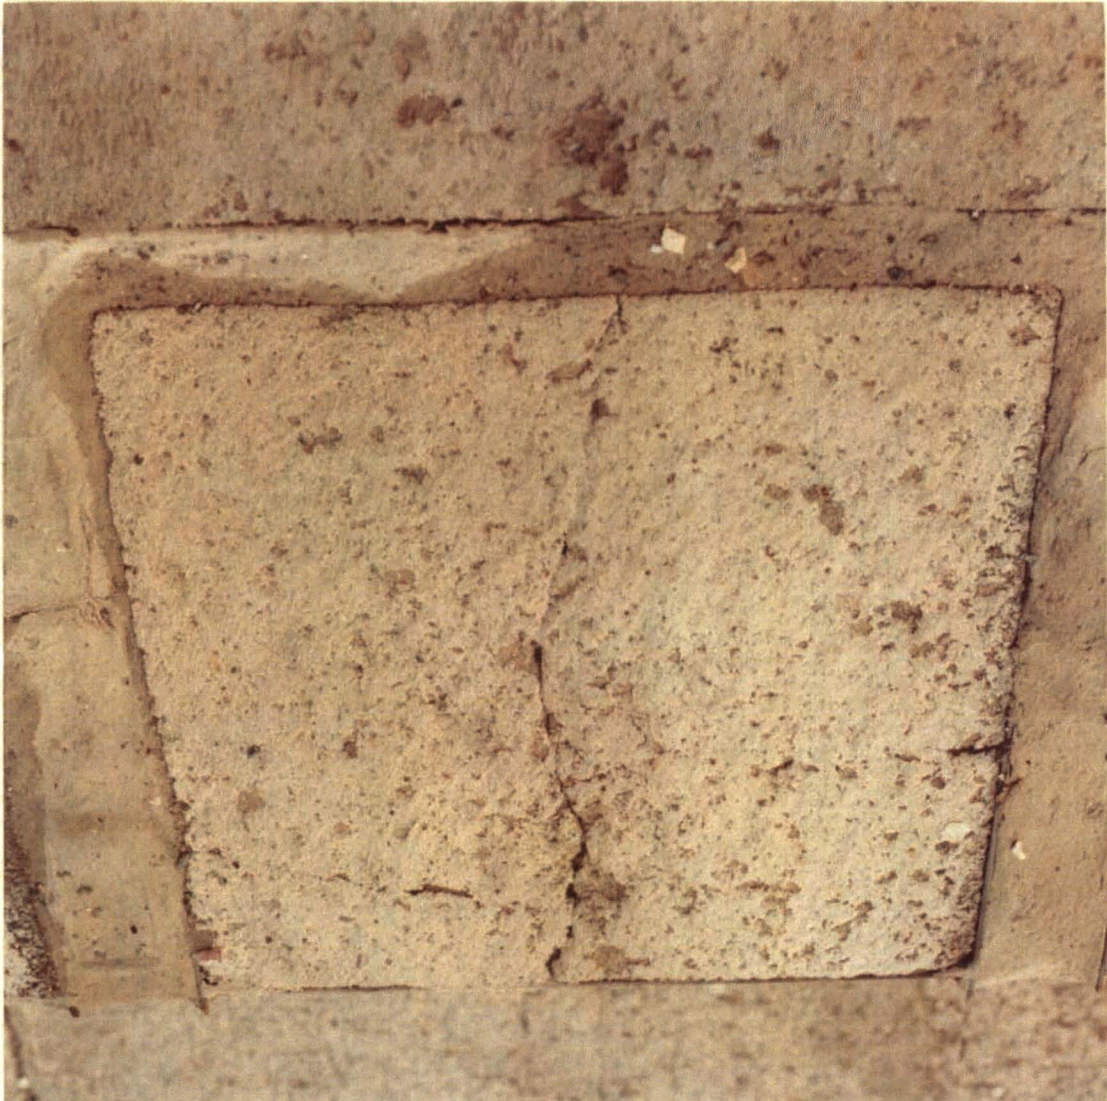
FIGURE 7

PANEL 5 IN TEST FRAME, POSITION 2, AFTER STS-2 LAUNCH.  
HARBISON-WALKER TUFSHOT WITH "FIBERS" (310SS)

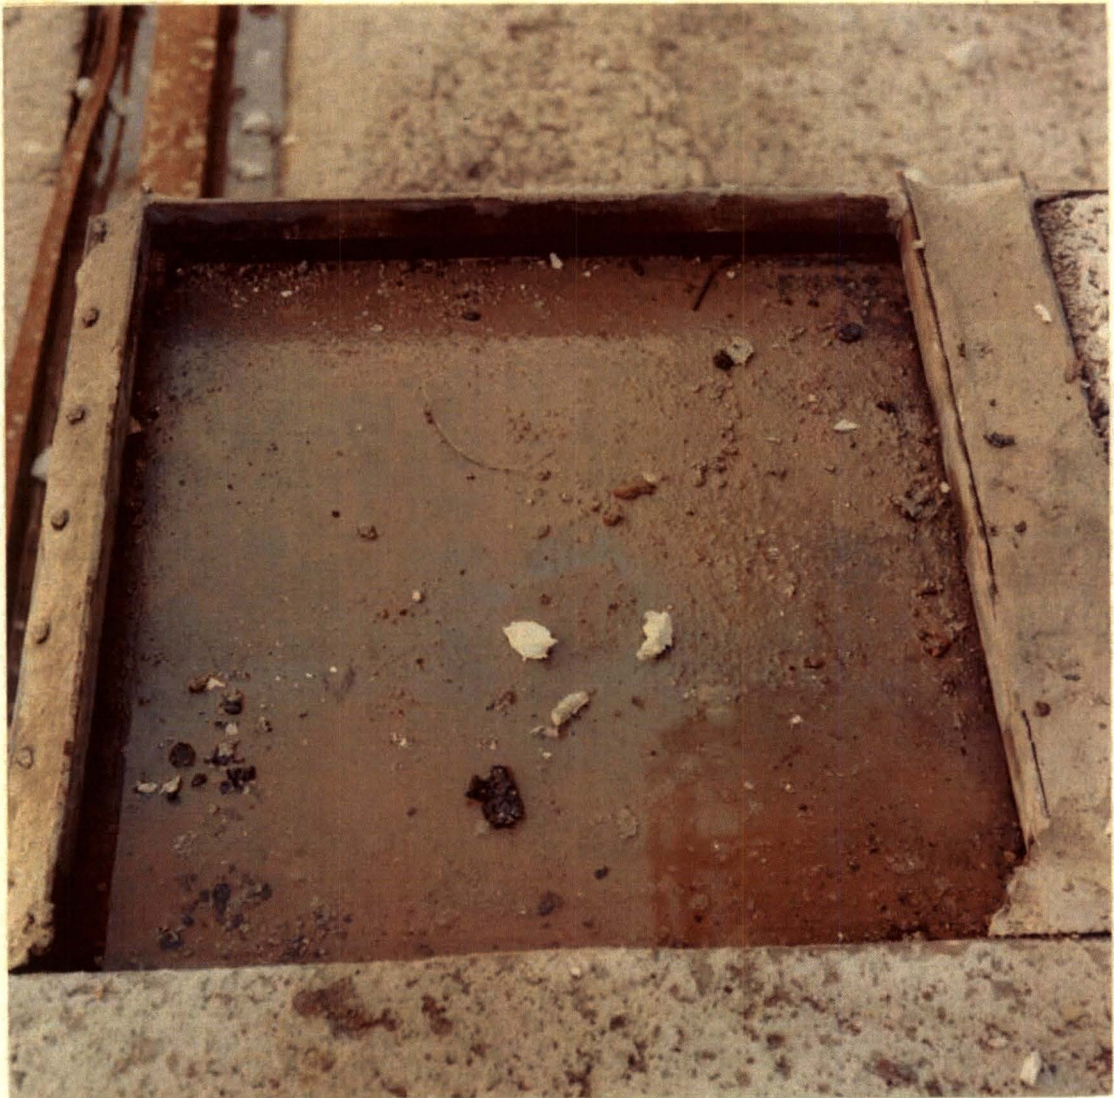
FIGURE 9

TEST FRAME, POSITION 3, AFTER STS-2 LAUNCH. THE REMAINS OF PANEL 6, HARBISON-WALKER TUFSHOT, HAD BEEN REMOVED BEFORE PANEL RETRIEVAL.

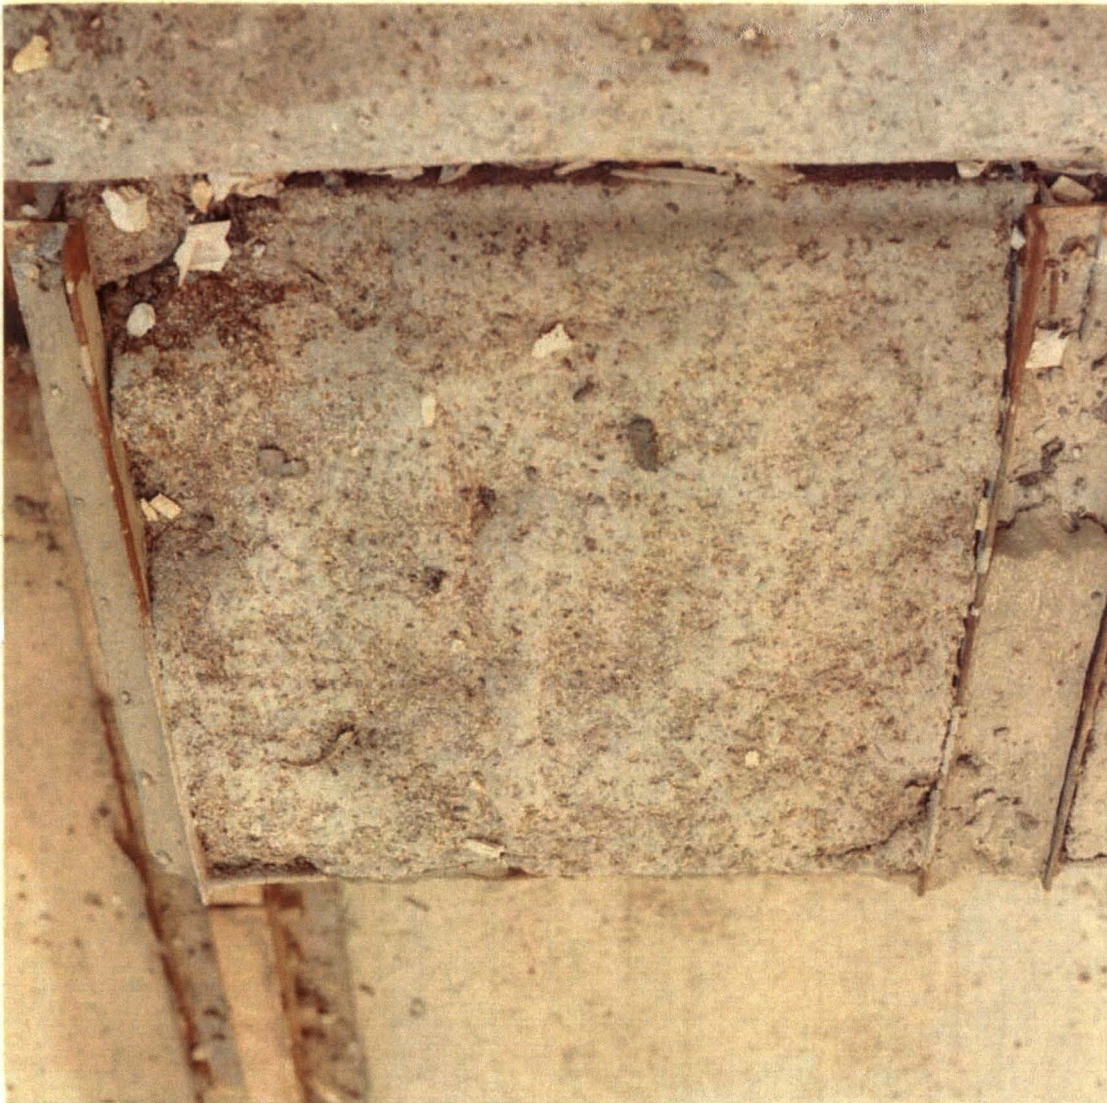
FIGURE 11

PANEL 7 IN TEST FRAME, POSITION 4, AFTER STS-2 LAUNCH

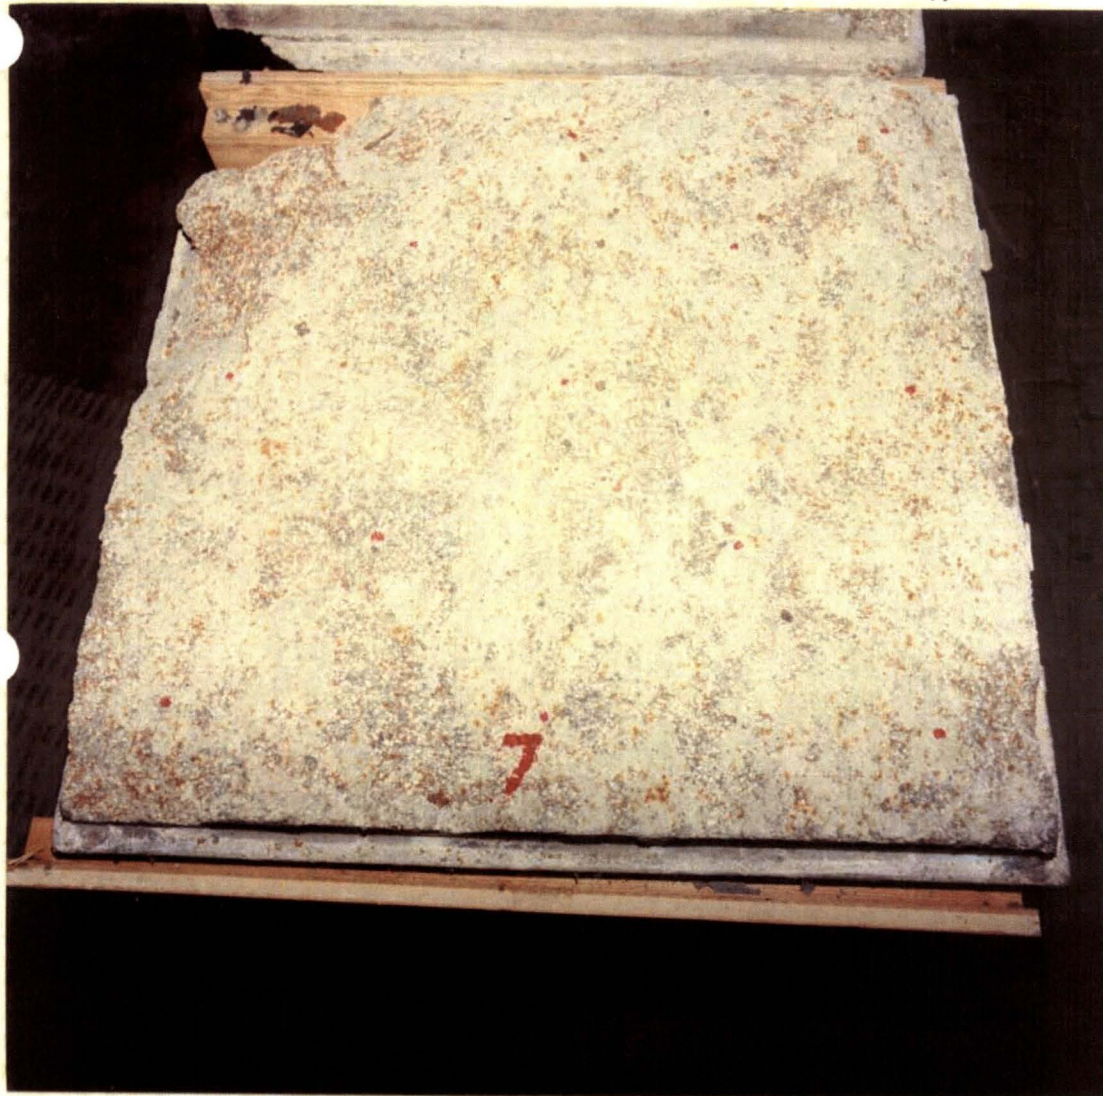
FIGURE 12  
PANEL 7 IN INSPECTION RACK AFTER STS-2 LAUNCH

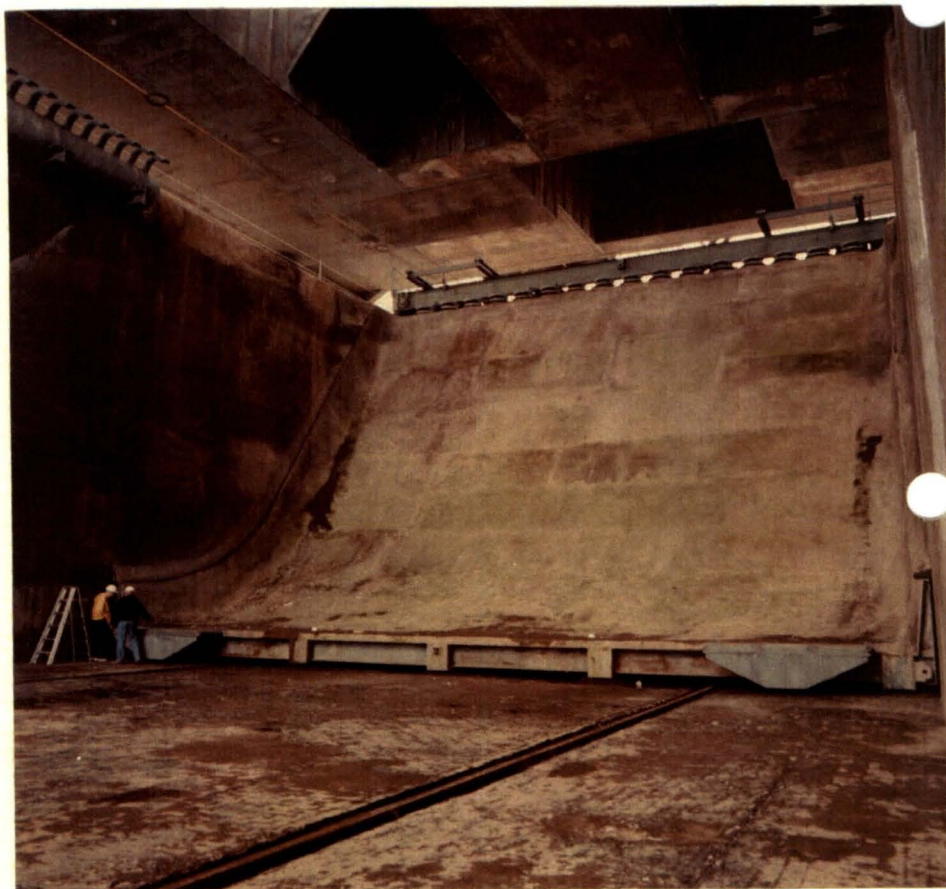
FIGURE 1  
FLAME TRENCH, SHOWING TEST FRAMES AT BOTTOM OF FLAME DEFLECTOR

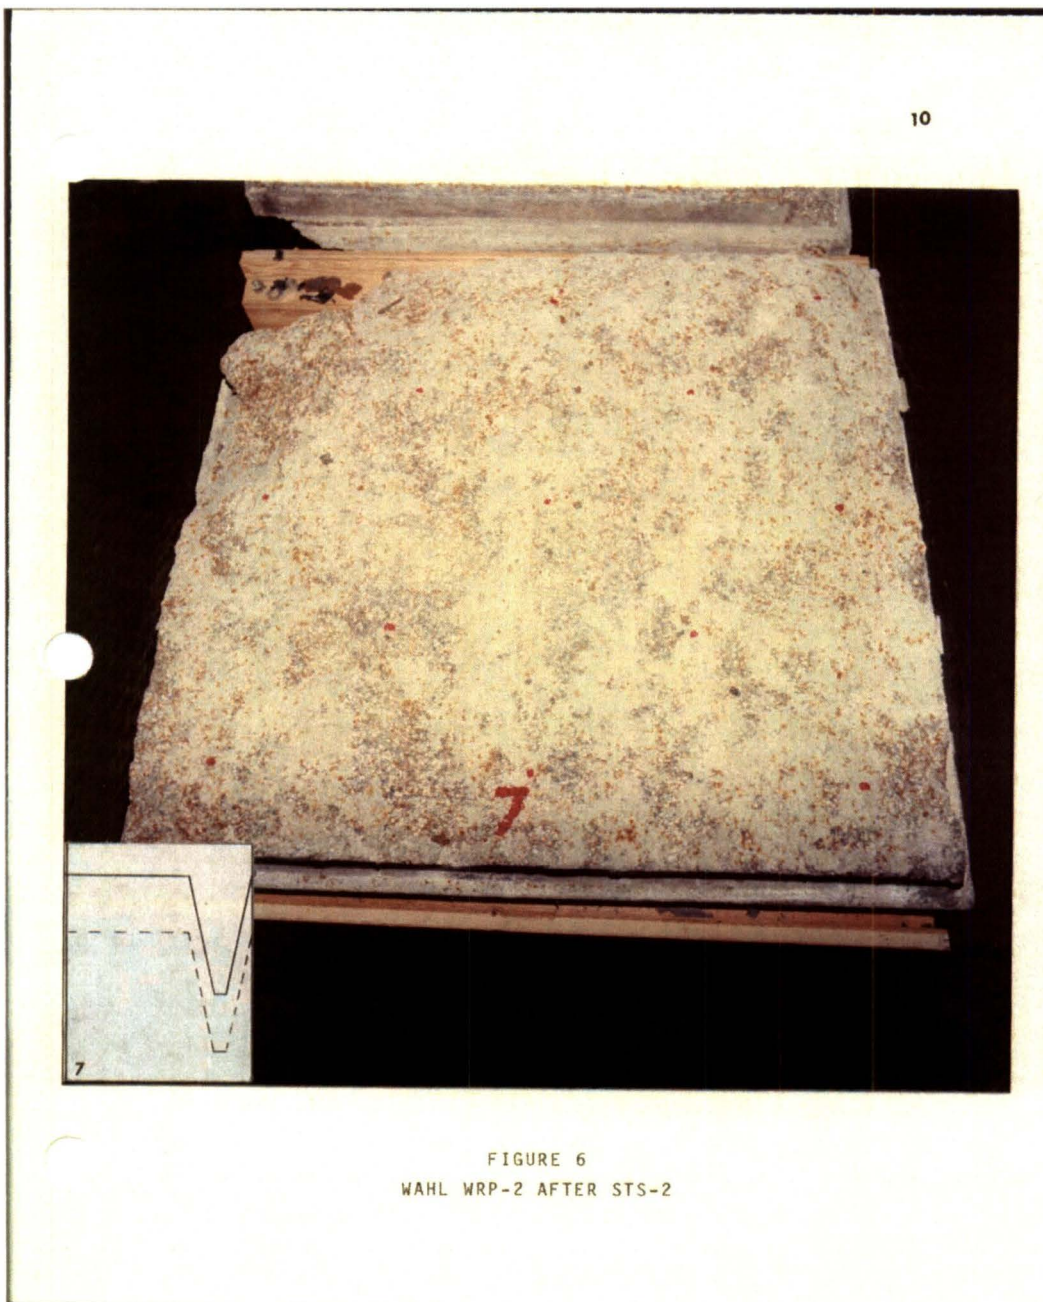
FIGURE 7  
WAHL WRP-3 AFTER STS-2

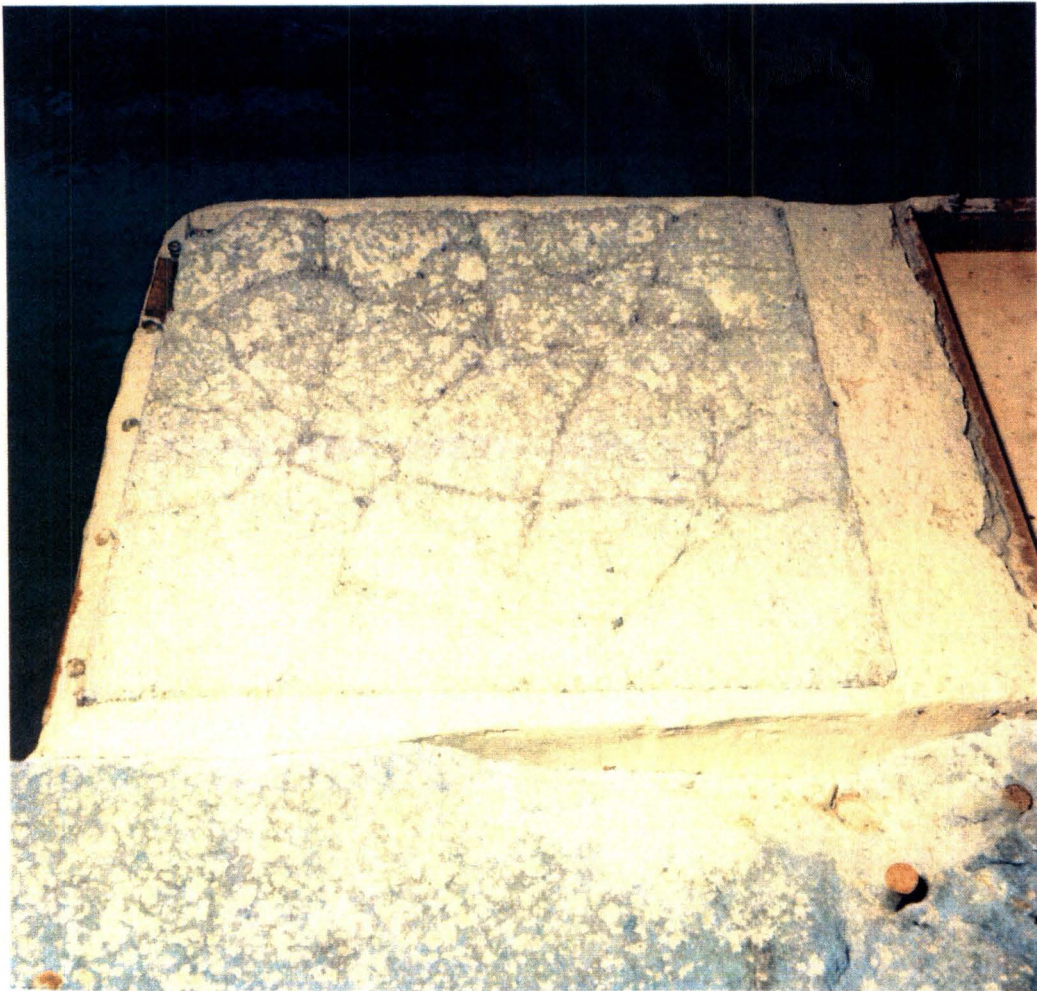
FIGURE 3

MITEC TEST SPECIMEN AT LOCATION "C" AFTER LAUNCH. THE TEST SPECIMEN CONTAINED NUMEROUS CRACKS AND WAS GROSSLY ERODED, ESPECIALLY ALONG THE CRACK LINES.
